Re: March 2013 Monthly Progress Report
Administrative Settlement Agreement and Order on Consent for Removal Action
U.S. EPA Region 10 Docket No. CERCLA 10-2009-0255
Gasco Sediments Site within the Portland Harbor Superfund Site

Attachment A Monthly Visual Monitoring Report for Pilot Cap Vicinity

Visual Observations Log Form

Monitoring Period: Monthly (Year 7)—March 2013

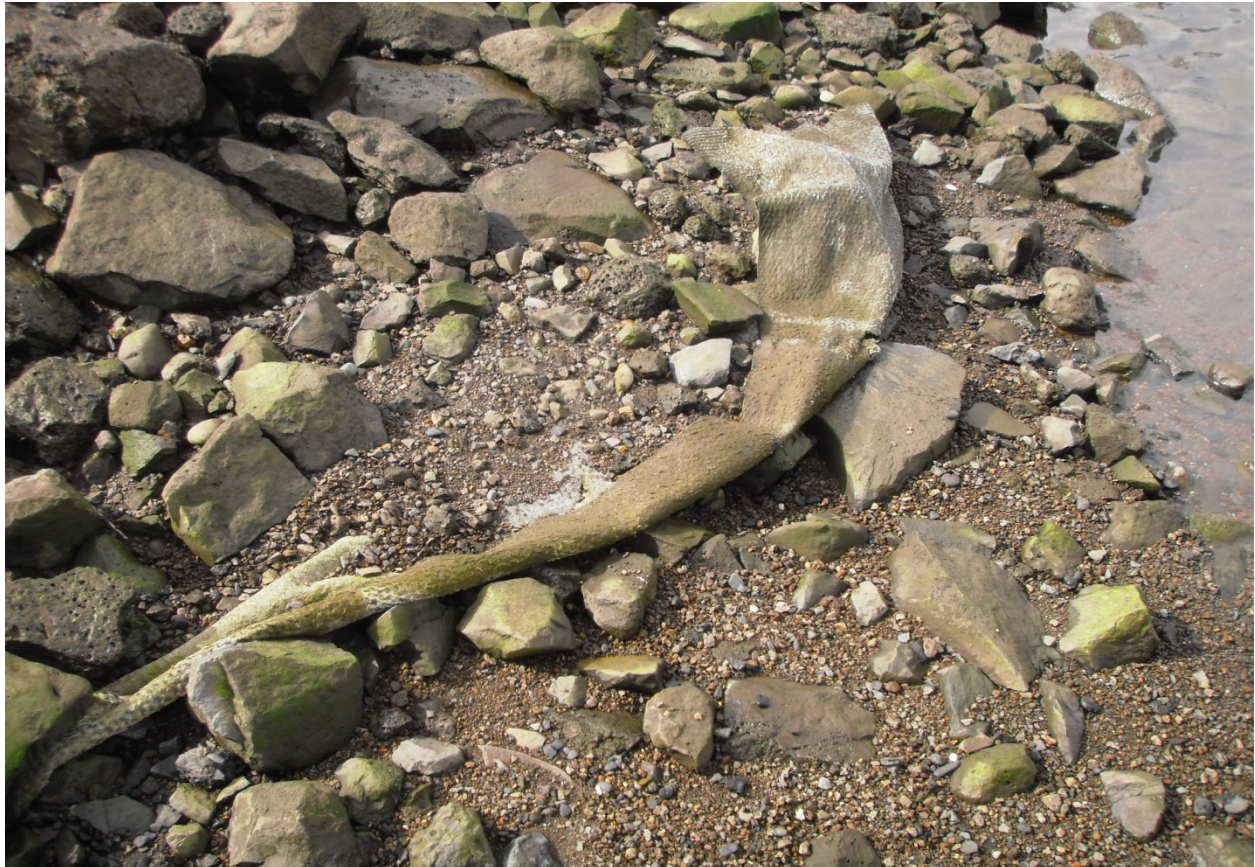
Observations of Erosion/Deposition: No erosion/deposition is evident along the shoreline. . Four organoclay mat material segments are exposed and visible. One 20-foot section of organoclay mat is partly out of the water at the upriver extent of the cap area perpendicular to the shoreline. Two exposed segments measuring 4-feet and 2-feet in length are submerged approximately 2 feet from the shore near the lateral mid-point of the cap area. One 40-foot section of organoclay mat material is exposed at the river's edge, near the downriver extent of the cap area. (Photo 1).

Photo 1 — *Visible section of organo-clay mat at the mid-section of the sediment cap (3/22/13):*

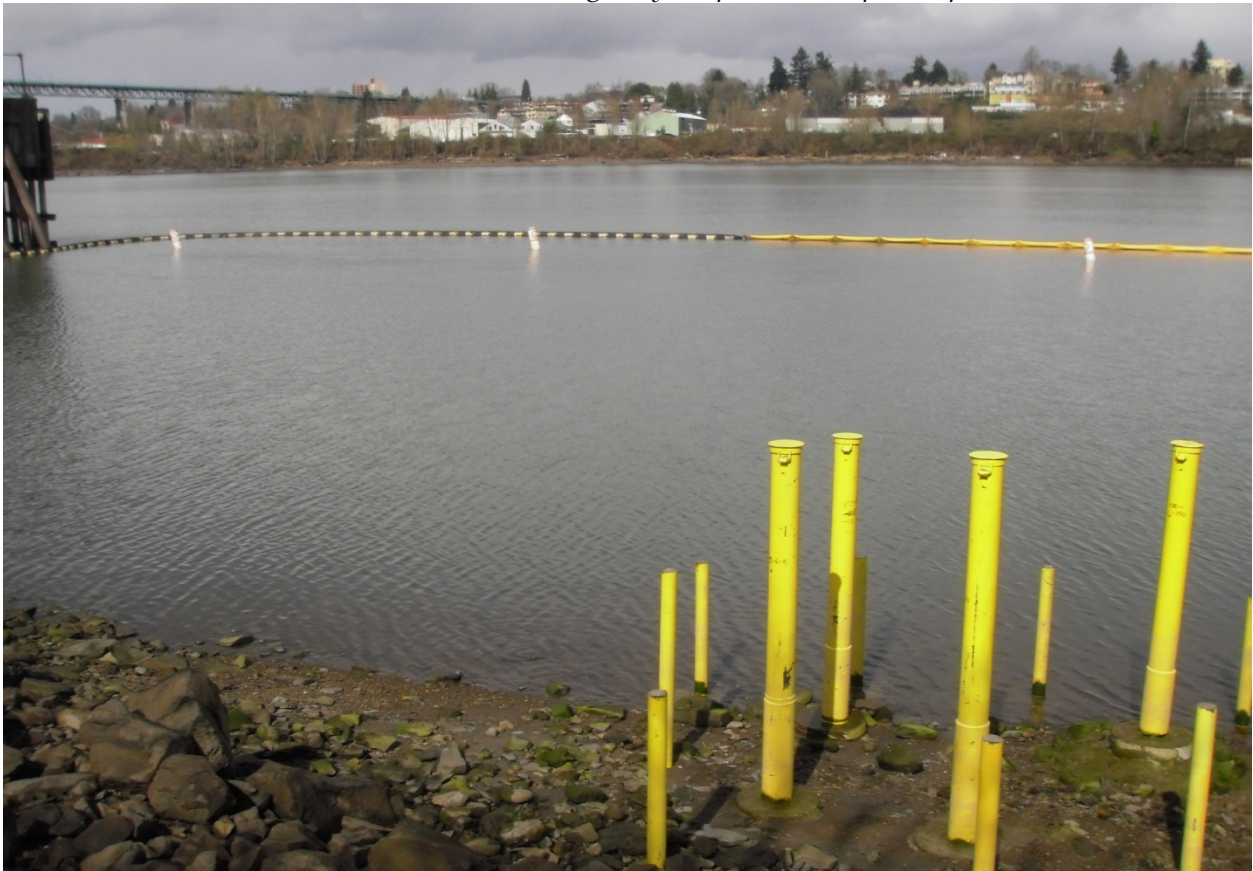
Observations of Long-term Controls (i.e., oil booms, organo-clay mat, etc.) During the observation, the Fuel and Marine Marketing (FAMM) containment boom was placed across the cap area, between the upriver corner of the ship dock and the wooden dolphin (near the upriver extent of the site and near the Siltronic Corporation outfall). Buoys that identify the cap area to mariners are in place as installed. The position of the FAMM oil boom, warning buoys, and a general overview of the site shoreline is shown in Photo 2.

Photo 2 — *FAMM oil boom and mariner warning buoys in place across pilot cap area. 3/22/13):*

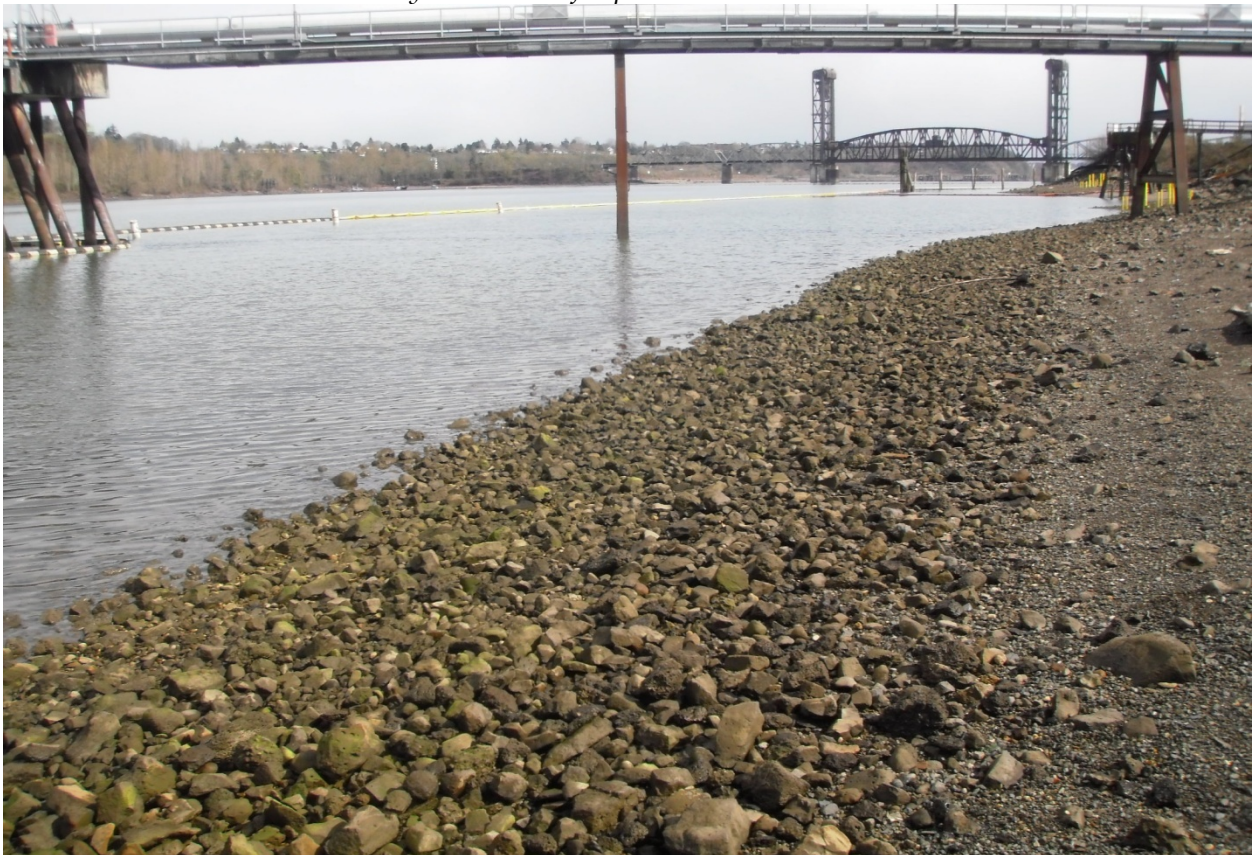
No sheen is evident in or around the cap area. Photo 3 shows the water surface and shoreline immediately downriver of the sediment cap.

Photo 3 — *Conditions immediately downriver of cap area (3/22/13):*
